Subject: Asbestos & Lead Survey Report
Moorpark College – Administration Building Reconstruction Project
7075 Campus Road
Moorpark, CA 93021
FCG Project Code: VCCCD-03

FCG Environmental (FCG) performed a hazardous materials survey of the Administration Building located on the Moorpark College campus, which included asbestos bulk sampling and lead-based paint testing. The investigation was conducted by FCG personnel on September 13, 2021, under the supervision of Alan Forbess, a CA Lead Inspector/Assessor and Project Monitor (No. 505/504) and CA Certified Asbestos Consultant (No. 94-1549). This report documents the results of our survey, which was conducted to identify proper handling of hazardous building materials prior to renovation activities.

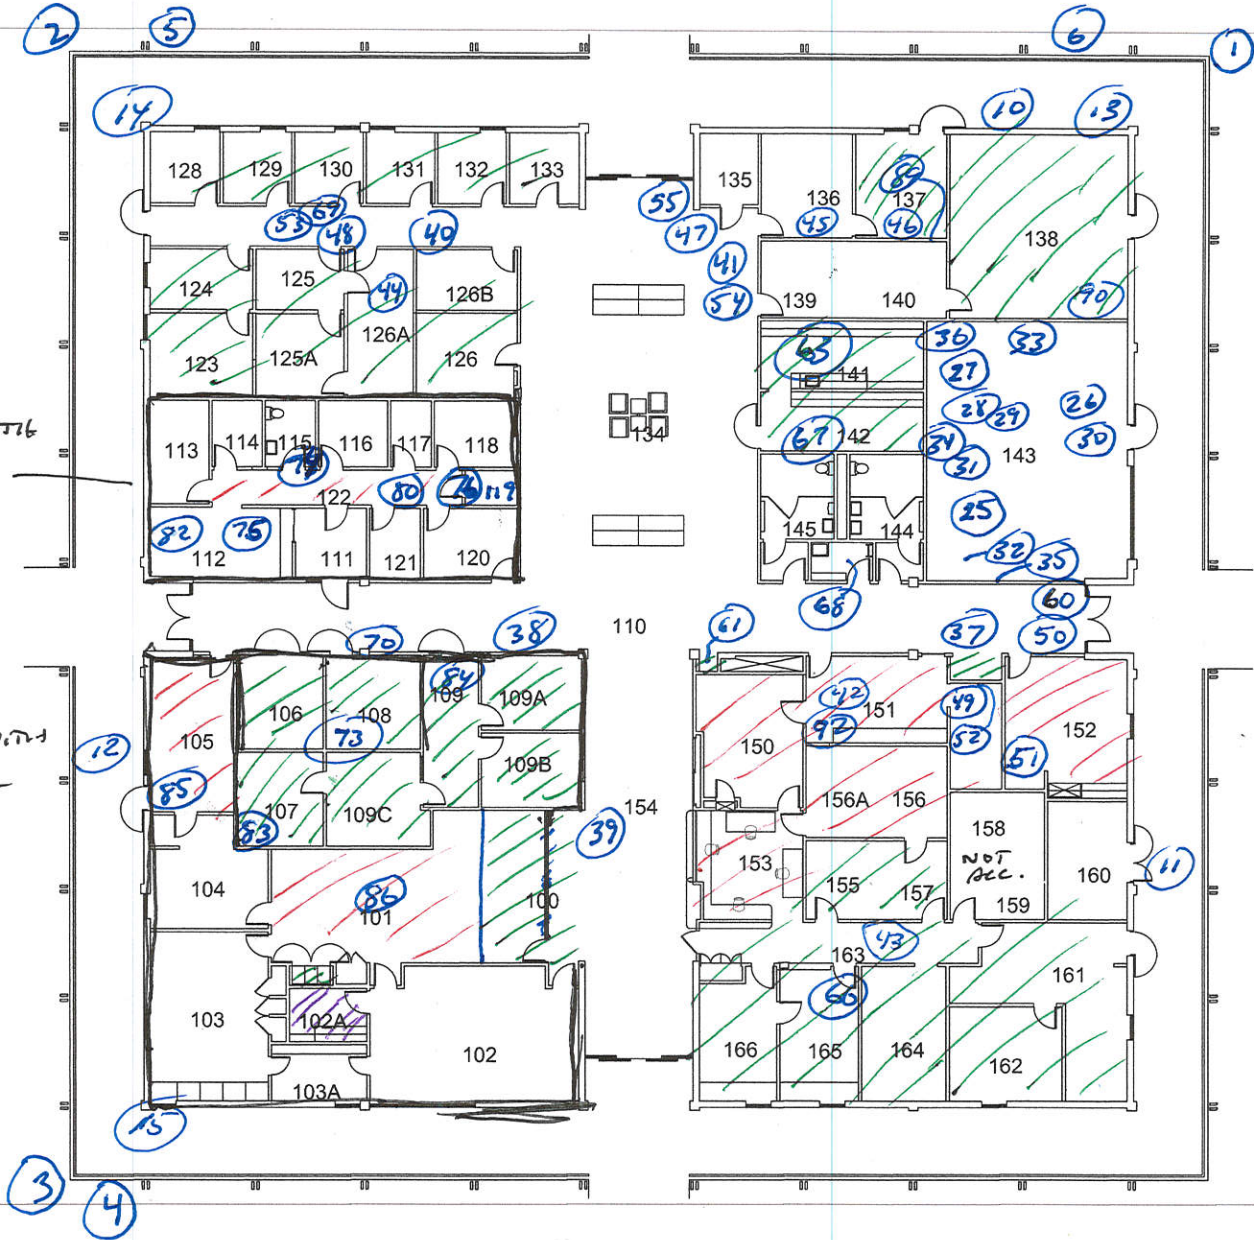
Field Plot with Sampling Locations

AREAS WITH
DRYWALL

111 9" VFT
OFF WHITE

111 12" VFT
BEIGE

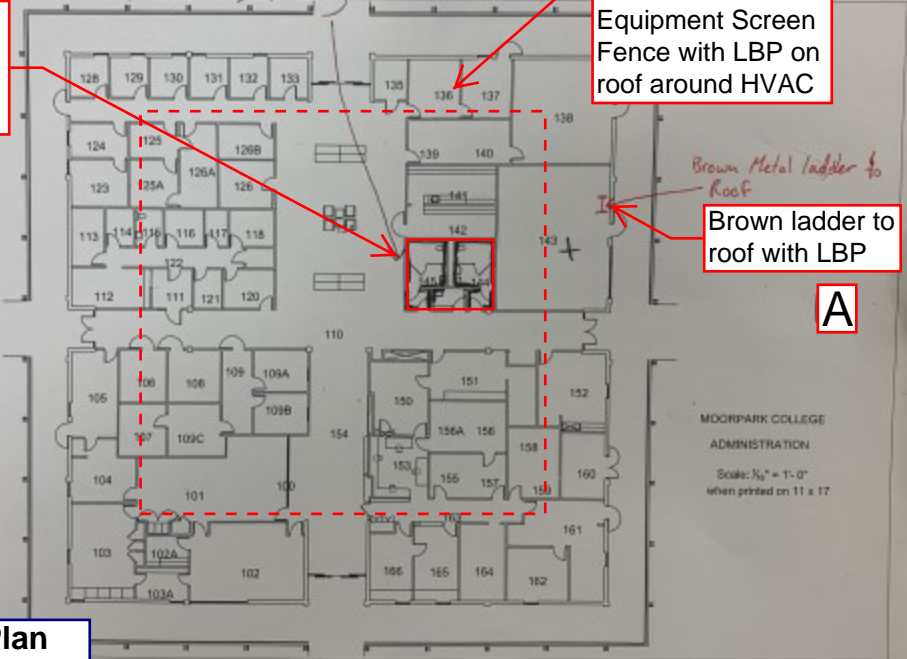
**Lead Plot Plan
 Moorpark College
 Admin. Bldg.**

- 1) The painted metal frame (white) of the equipment screen fence on the roof and the roof access ladder (brown) meet the definition of Lead-Based Paint (LBP) as noted in Section 3.0 of this report, with lead concentrations above the 1.0 mg/cm² regulatory level by XRF testing methods. These materials will require the implementation of lead-safe work practices if they are disturbed as part of future renovation activities. Please refer to the attached XRF data table for a complete list of all field readings for lead paint, with locations noted. The A side on the table is the north side of the site, with the B, C and D sides following in a clockwise direction around the site.

Brown ladder to
 roof with LBP

- 3) It is the responsibility of the contractor conducting LBP or lead component (ceramic tiles, porcelain, etc.) disturbance work to protect employees, the general public and prevent contamination of the site when disturbing lead. The contractor must comply with current OSHA regulations and the EPA's Renovation Repair and Painting (RRP) Rule, which requires the use of "lead safe work practices" when disturbing lead. This includes the use of wet methods, proper containment and dust controls during all disturbance work where lead dust may be generated. Proper clean-up using HEPA vacuums and damp wiping methods are also recommended. The use of mechanical means (i.e., sanding, grindings, etc.) to remove paint with detectable levels of lead is not recommended unless the equipment is properly equipped with HEPA exhaust. Please see the attached Lead Safe Work Practices for detailed information on proper work practices and procedures.
