# SPEARHEAD

### UTILITY SURVEY REPORT

| <b>CUSTOMER:</b> | Ventura college |
| <b>PROJECT:</b> | head house water science hoop house |

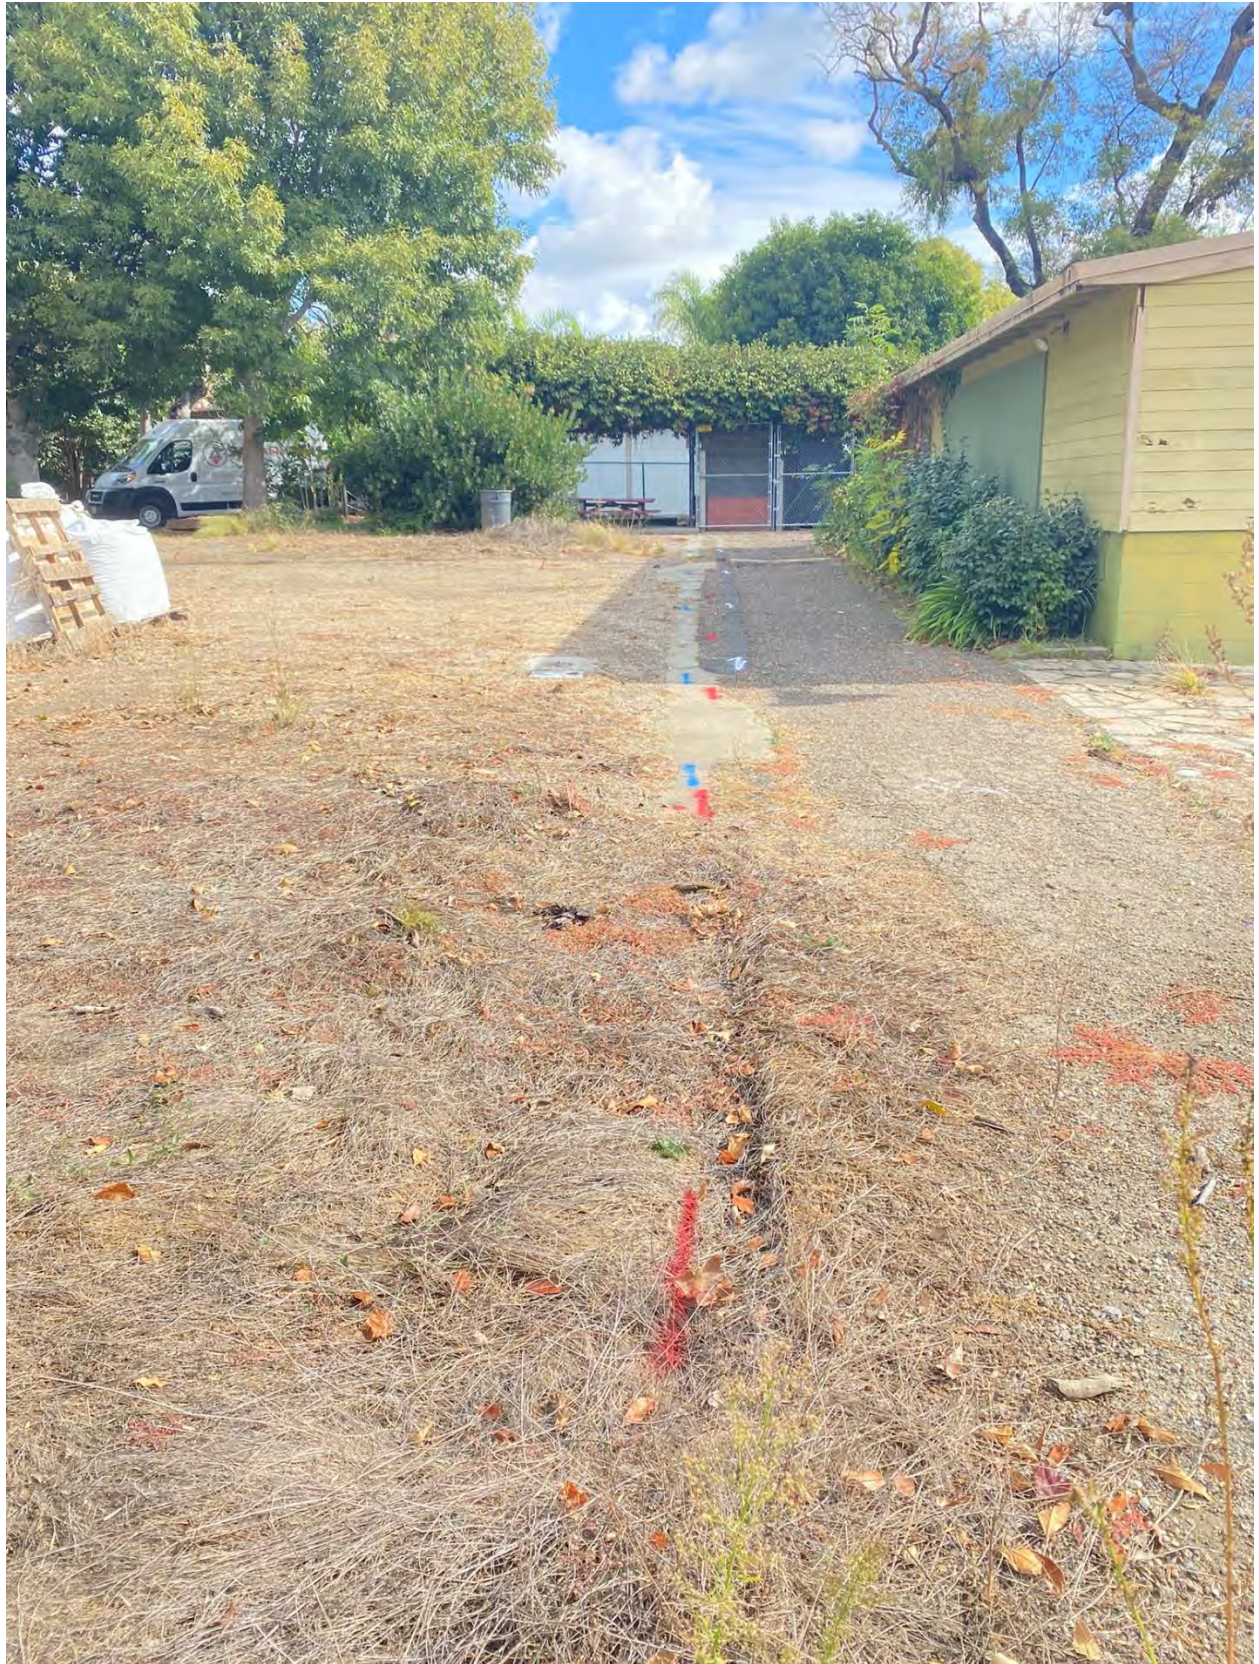
White line is an abandoned electric line.

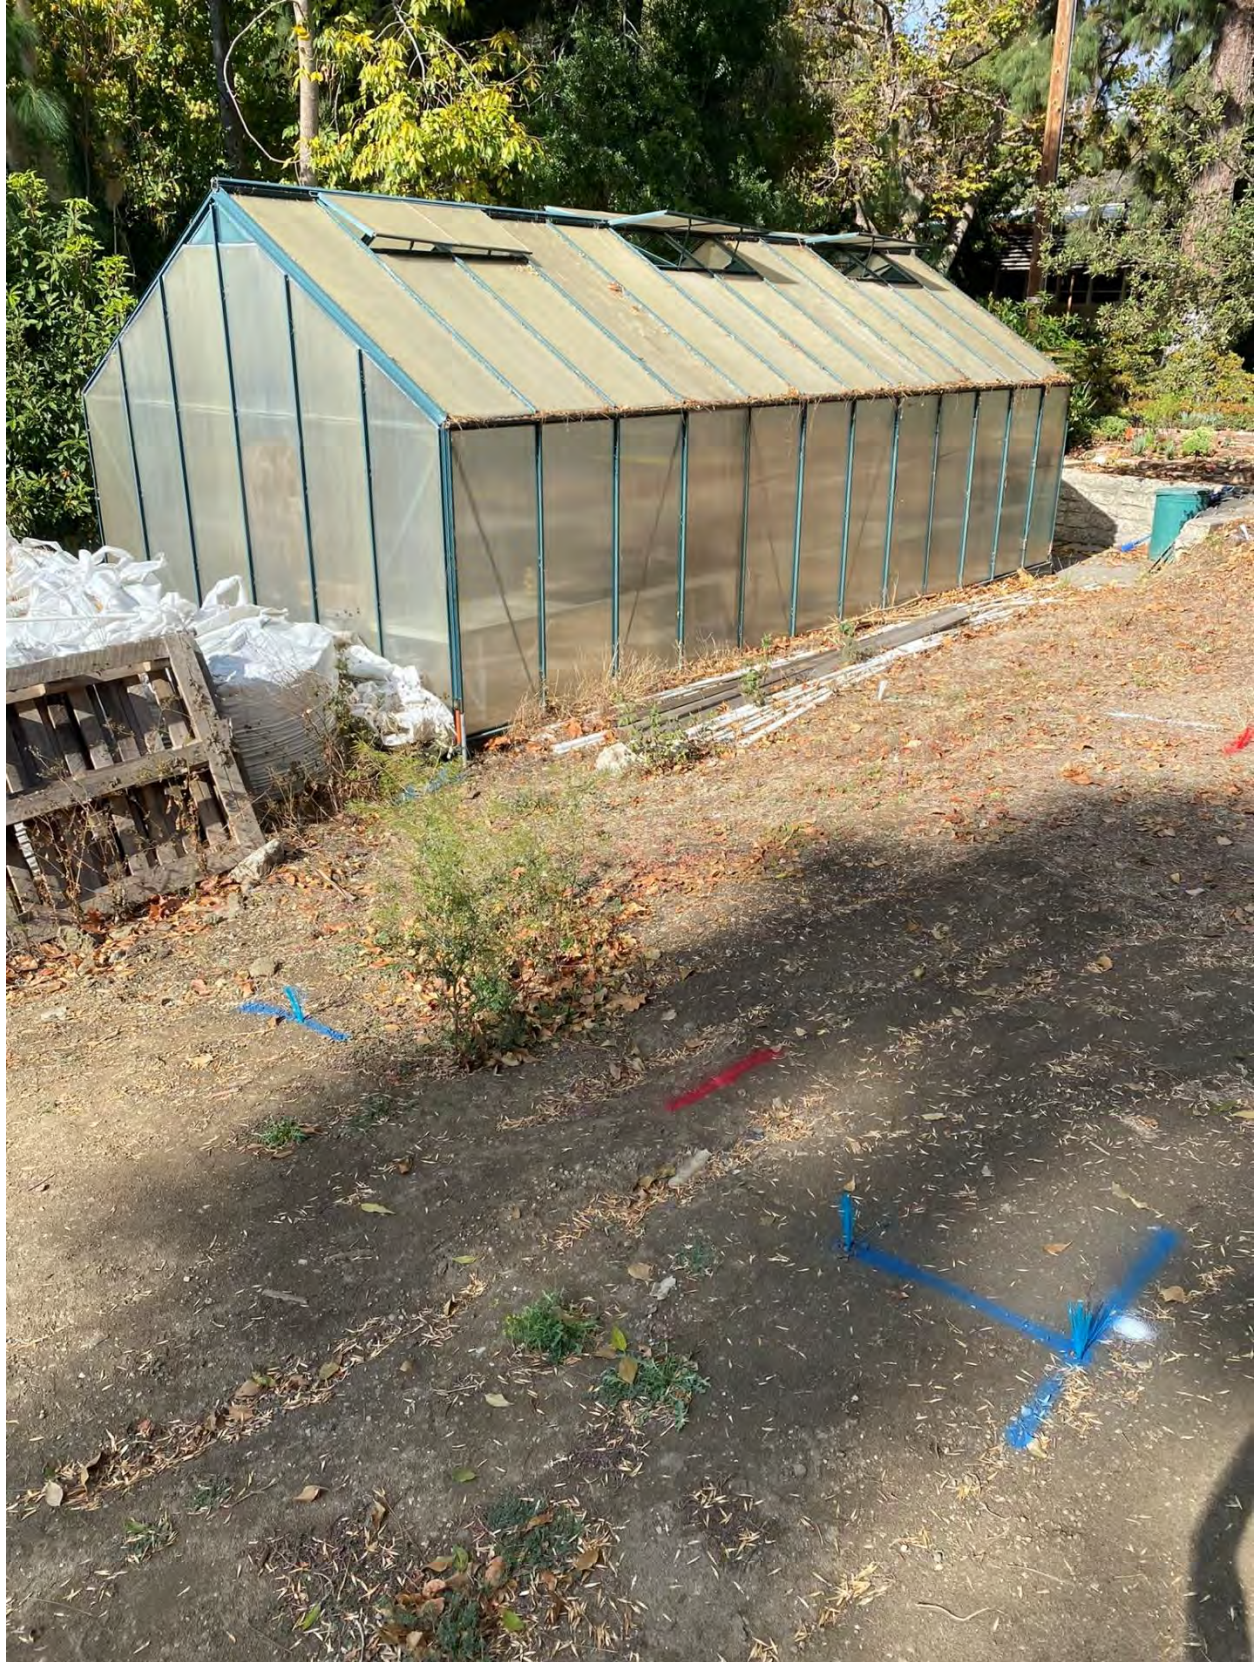
Electric is approximately 2'6" deep, water is approximately 18" the 2 unknown lines could not get a depth.
